Report on Research Commissioned
by Mugen Denko Co.,Ltd.

Rider Jacket Evaluation Test

Japan Automobile Research Institute, Inc.

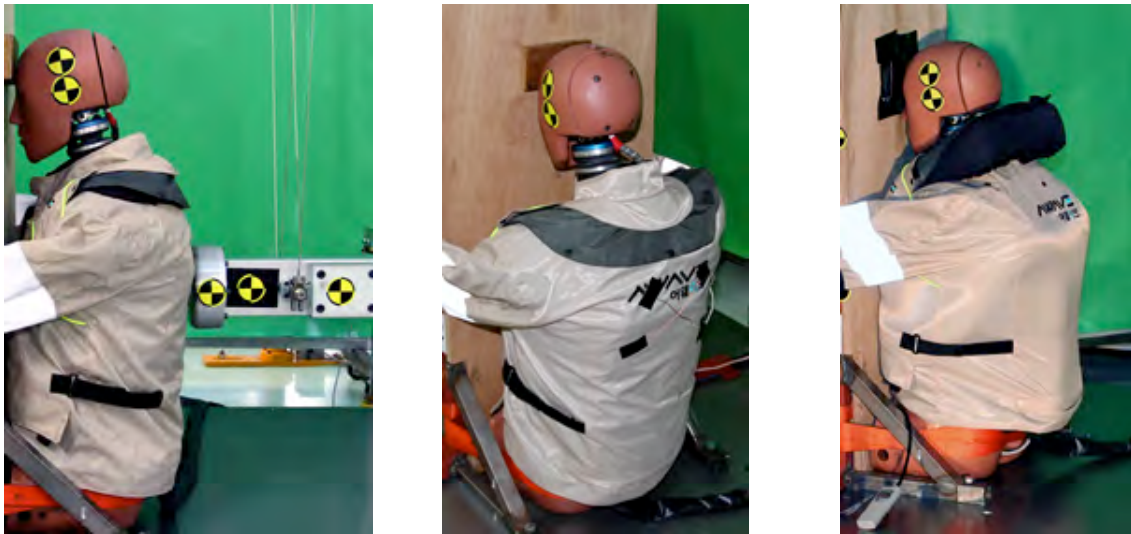
Figure 1 shows the photographs of the dummy's jacket clothing condition with impact to be applied to the back of the dummy. The test conditions employed with regard to the rider jacket were: a) the dummy without any jacket on, b) the dummy clothed in a jacket but the airbag not inflated, and c) the dummy clothed in a jacket and the airbag inflated.

Fig. 1 Jacket clothing conditions in back impact test

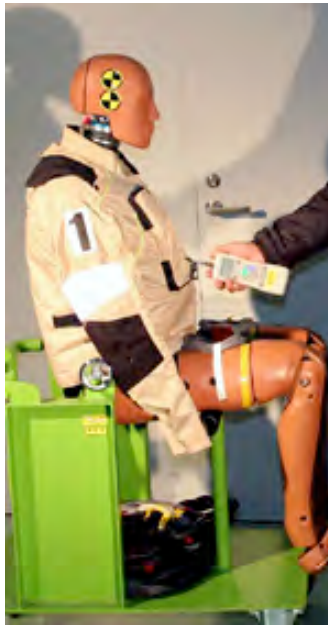
The rider jacket used in the present study was equipped with an automated system of injecting air into the airbag inside the jacket upon detection by sensors of the rider's separation from the motorcycle body. Therefore, another test was undertaken to measure the airbag inflation time from the activation of the air injection system to the inflation of the whole part of the rider jacket including the neck part. The inflation time was measured from the photo images of the dummy taken by the high-speed video camera. Figure 4 shows a typical scene of how the air injection system was activated in this inflation time test.

Fig. 4 Jacket inflation time test

The jacket inflation time test was undertaken using only one type of rider jacket. Table 3 shows the measured time required for the inflation of the neck part and the whole part of the jacket. The inflation time proved to be 80 msec for the neck part and 180 msec for the whole part of the jacket.
